## Lateral Bracing of Joists and Beams

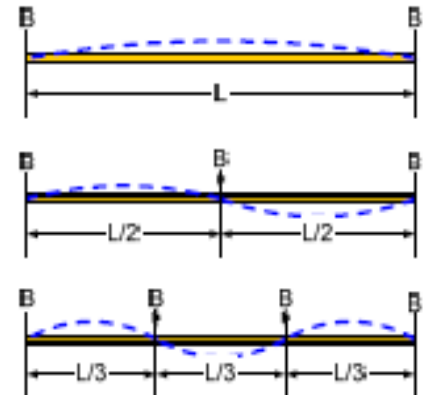
**Figure 2: Top Edge Buckling of Joists and Beams**

Bracing of joists and beams is as important, though may not be as apparent. When a joist or beam is loaded, compression and tension forces develop within the product. For simple span applications, the top flange of I-joists and top edge sections of beams are subjected to compression stress. As with vertical products, these compression forces can cause buckling if the top edge is not braced laterally (see Figure 2). Improper or absence of bracing significantly reduces the load-carrying capacity of the joist or beam.

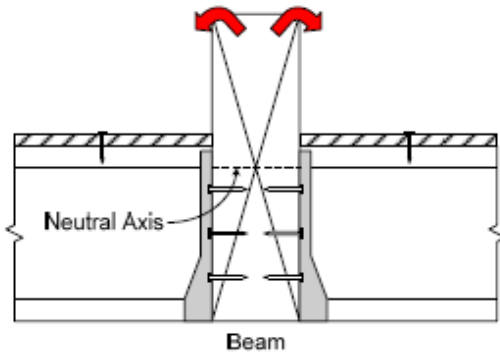
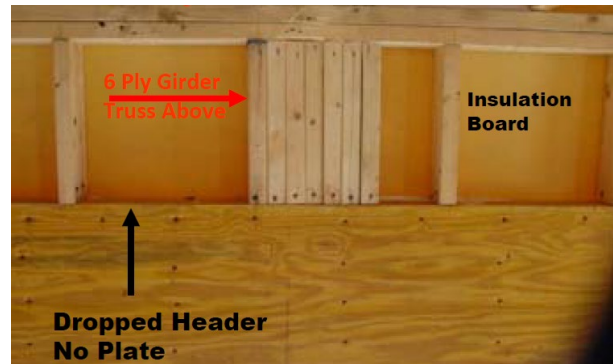
**Figure 4: Examples of Improper Lateral Bracing**

The following are examples of conditions that are not considered properly braced. Improperly braced applications should not be sized with either BC Calc® or Boise Cascade EWP literature. For further information regarding beam bracing, see the Wood I-Joist Manufacturers Association (WIJMA) *Dropped Header Design Guide* at [www.i-joist.org](http://www.i-joist.org).

Ceiling/attic joists are typically not sheathed in residential construction. When installing AJS® / BCI® joists in this application, the top flanges shall be laterally braced. In lieu of sheathing, 1x4 bracing can be installed perpendicular to the joists and attached with (2) 8d nails into each top flange. This bracing shall be installed at 24" on-center along the length of the joist. With this 1x4 bracing, joists may be sized utilizing BC Calc® or the allowable floor PLF tables shown in Boise Cascade literature. The only exception to this bracing spacing is the prescriptive ceiling joist design shown on page 14 of the BCI's and page 15 of the AllJoist Specifier Guides.

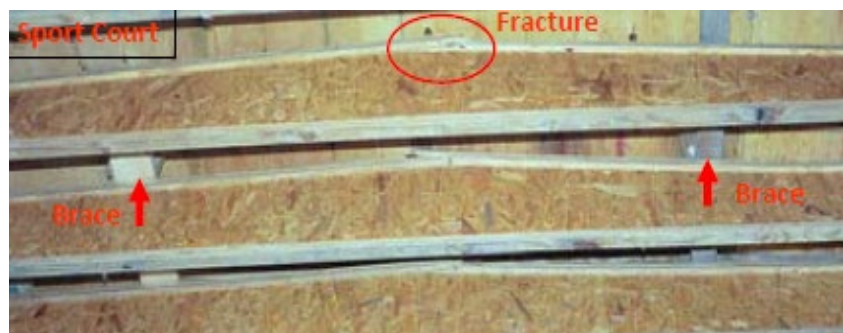
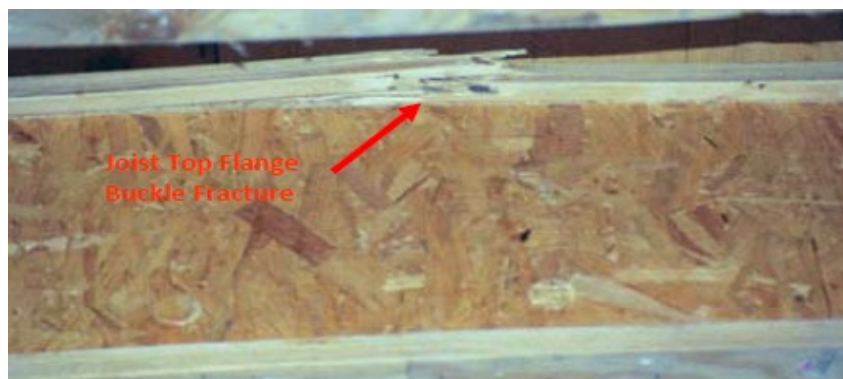
**Figure 5: Example of I-Joist Failure Due to Improper Flange Bracing**

Failures may occur due to improper joist/beam bracing. As shown in Figure 5, top flange buckling is likely when bracing is inadequate.

Bracing is a critical element of each joist and beam application. If sheathing is not directly attached to the top edge of the member, the project's design professional of record shall consider other bracing options. For further questions, please contact Boise Cascade EWP Engineering.
