# Predictive Analytics *PE6000* | *LM6000* | *LM2500*

Brian Roth  
VP O&M

# For the Life of the Turbine

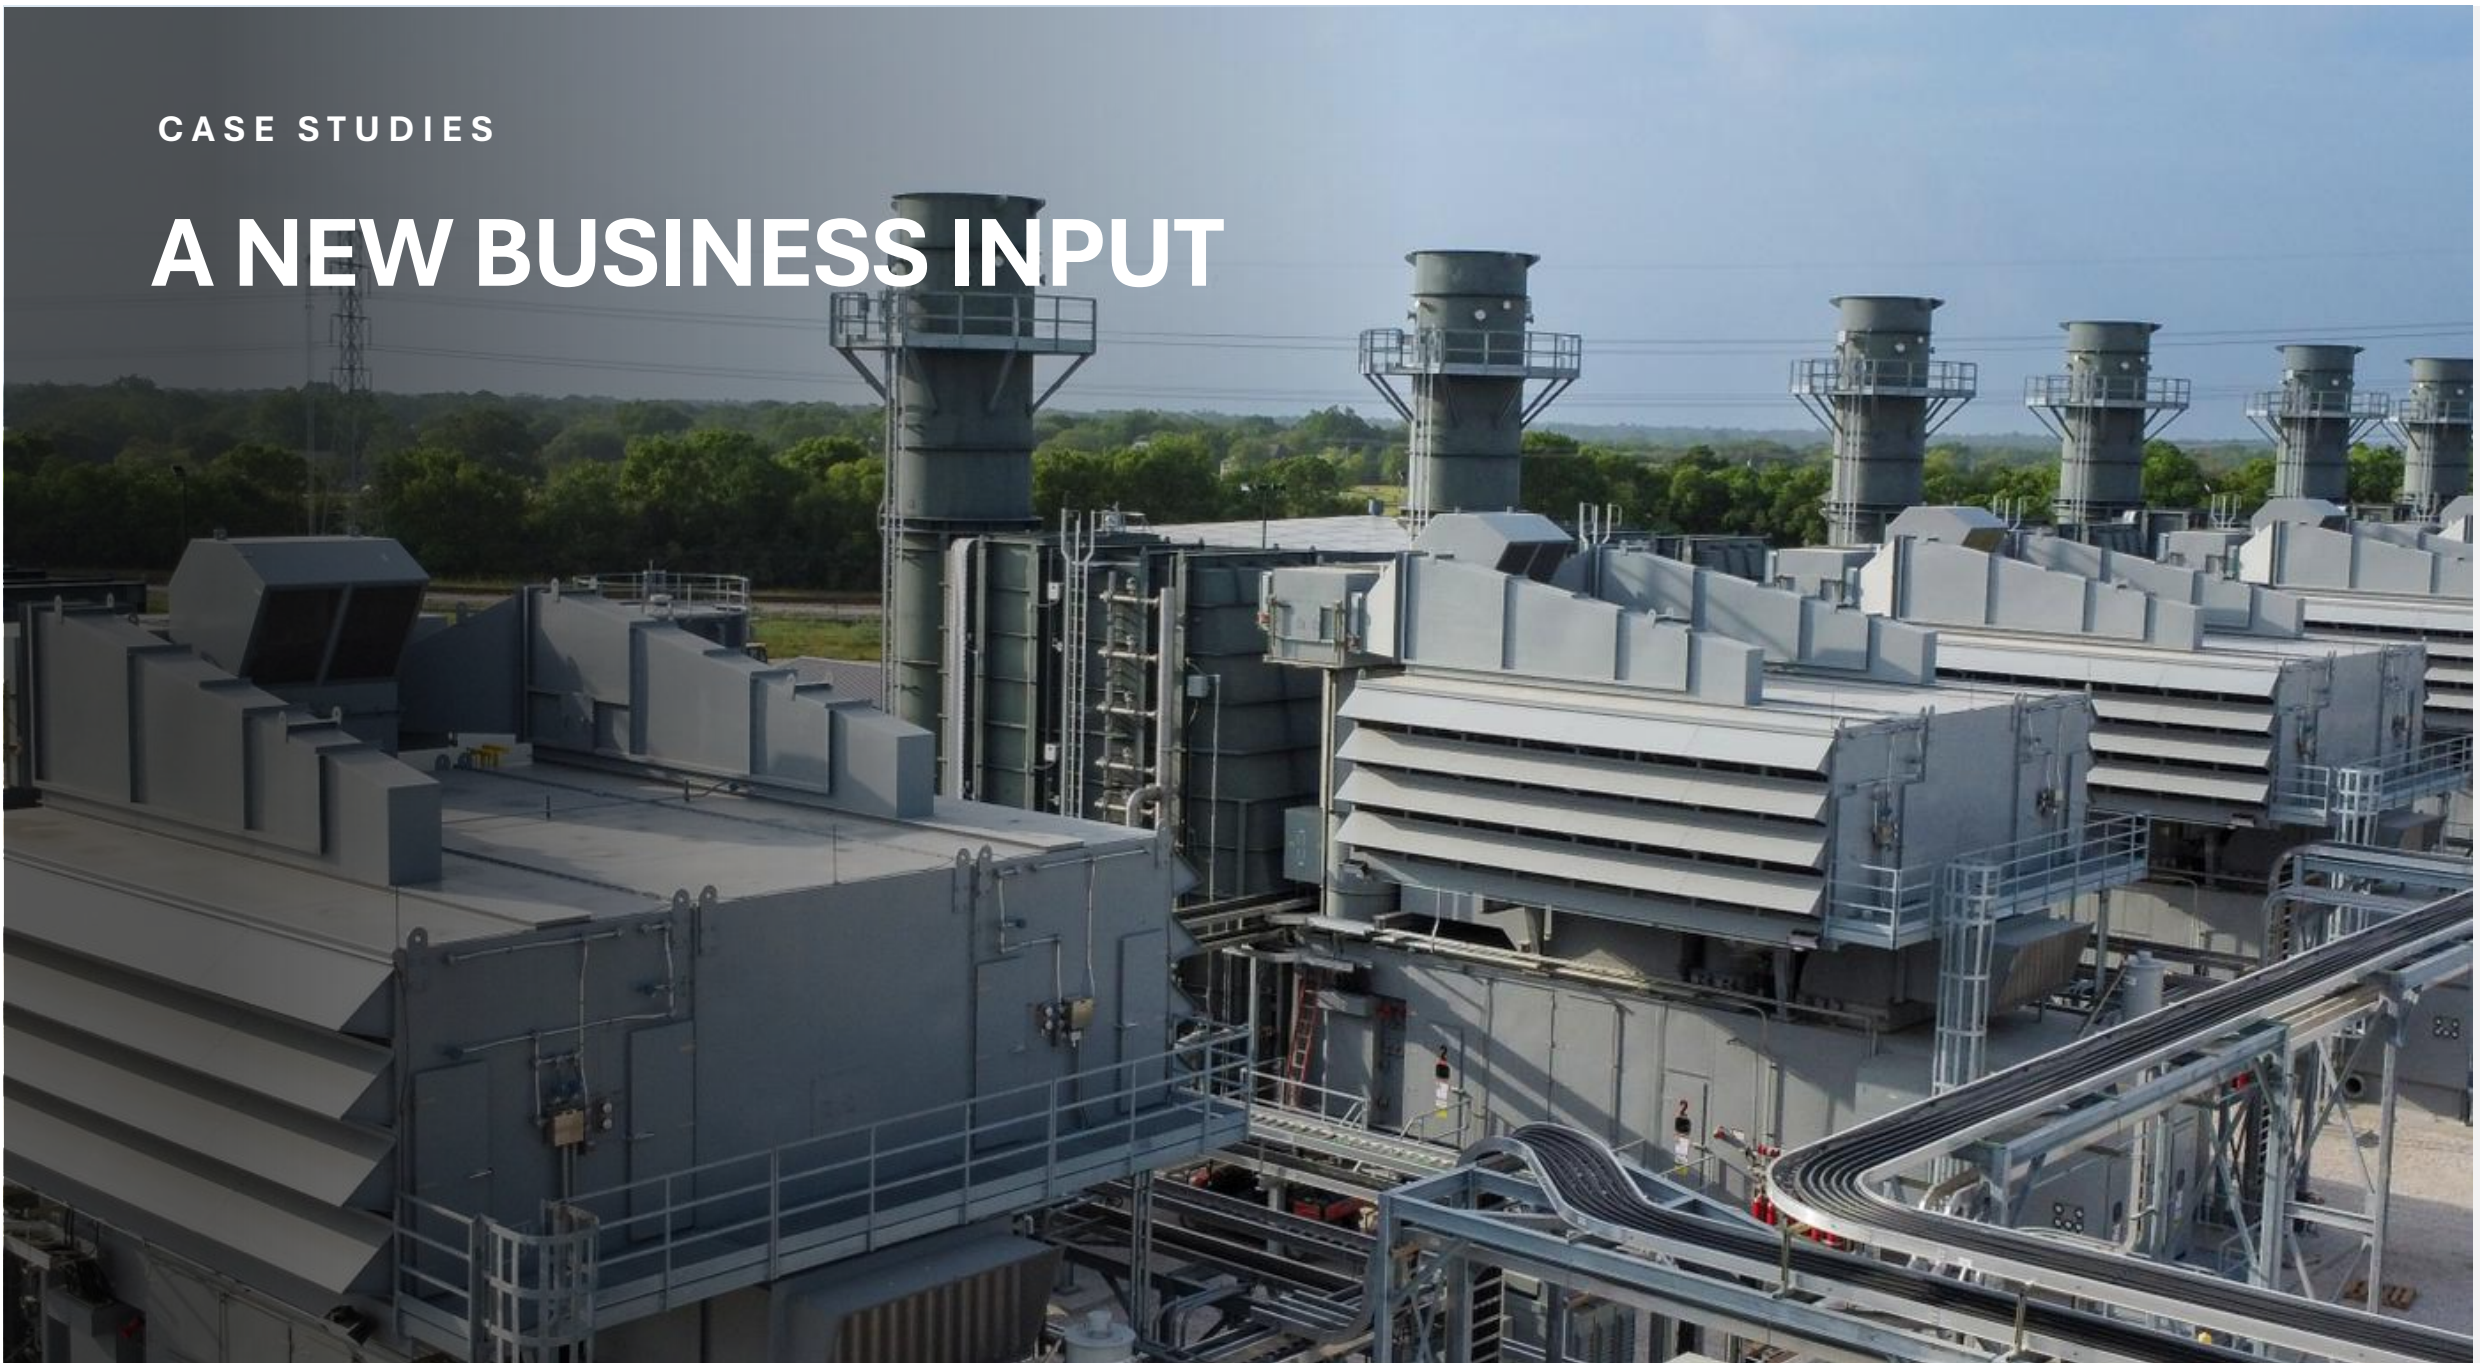
# Detected Failures >30 Days Early In Peaking Units

**Key points in the compressor showed degradations from normal operations.**

- Pressures
- Temperatures
- VG systems
- Measured from June 20 to Nov. 15, 2022
  - 1 minute frequency
  - 135 variables for each of the 2 units

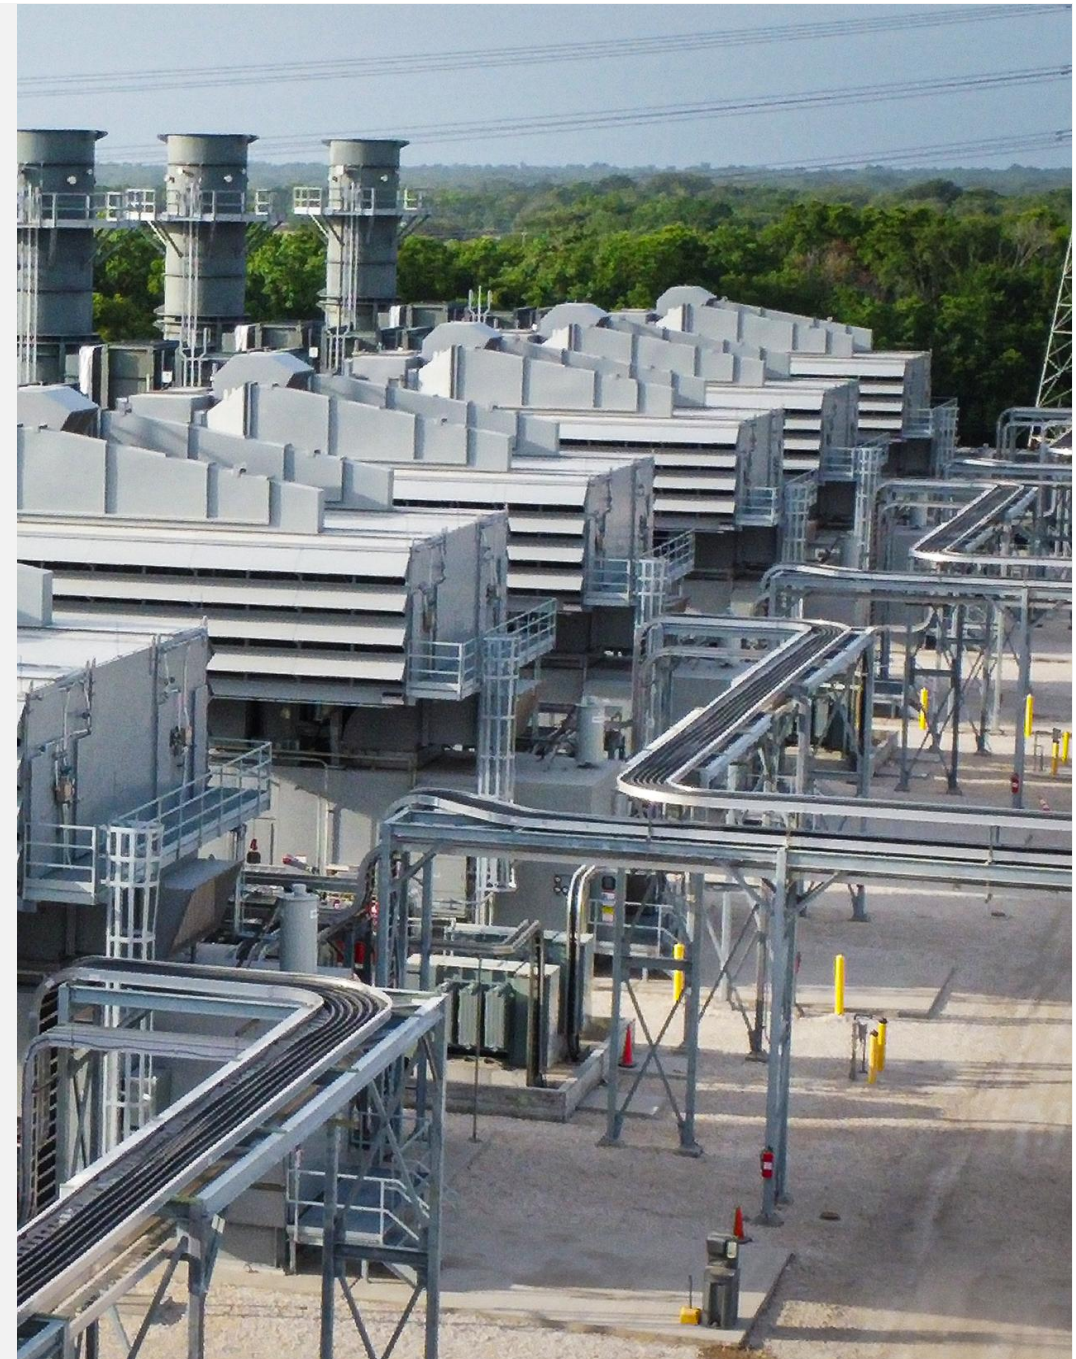
## CASE STUDY #1

# Compressor Issue Detected 38 Days Early

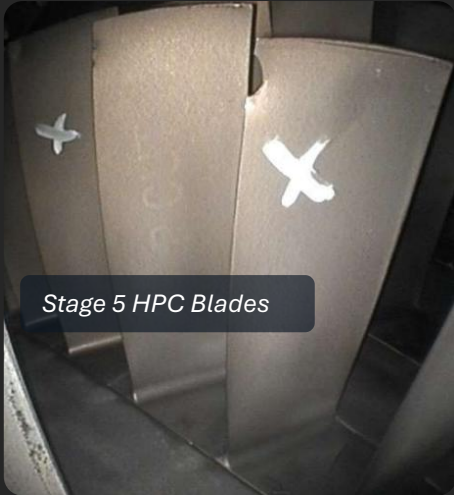
Stage 5 HPC Blades

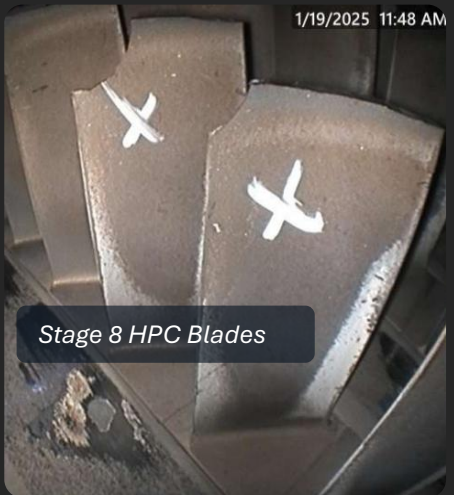
Stage 8 HPC Blades

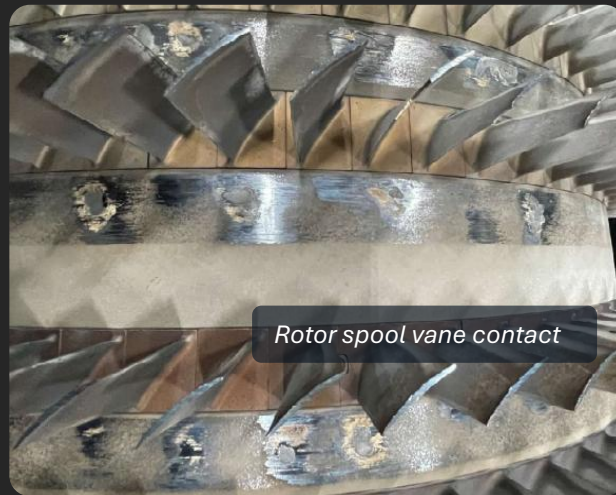
Rotor spool vane contact

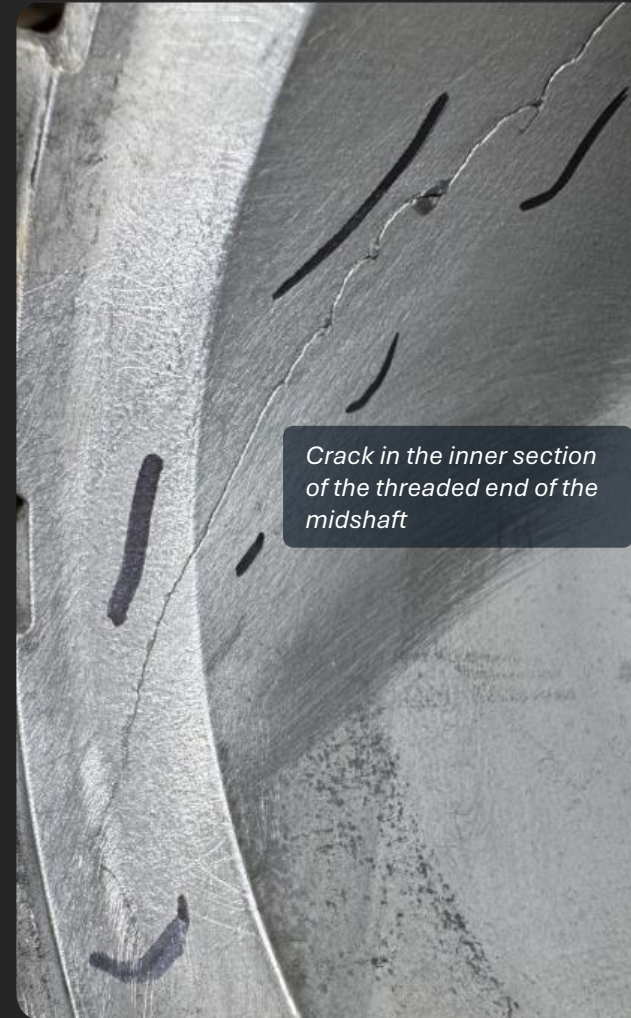
Crack in the inner section of the threaded end of the midshaft
