Enhancing Crane Maintenance Efficiency through Predictive Analytics:

A Case Study on AVEVA's Application in
Non-Continuous Operations

Özgür Özsoy

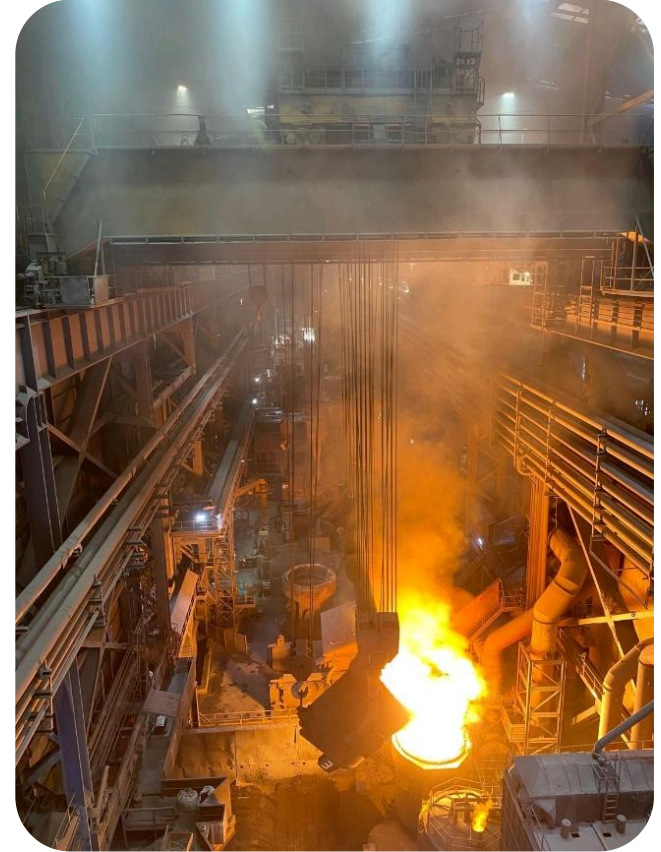
Meltshop Cranes

- Capacity: 500 / 120 / 30 Tons
- Span: 27.000 mm
- Top Of Rail: 35.000 mm
- Bridge Wheels: 32
- Bridge Gearboxes: 8
- 500 Ton Hoisting Gearboxes: 3
- 500 Ton Drums: 2
- Wire Rope Assembly: 4 // 32

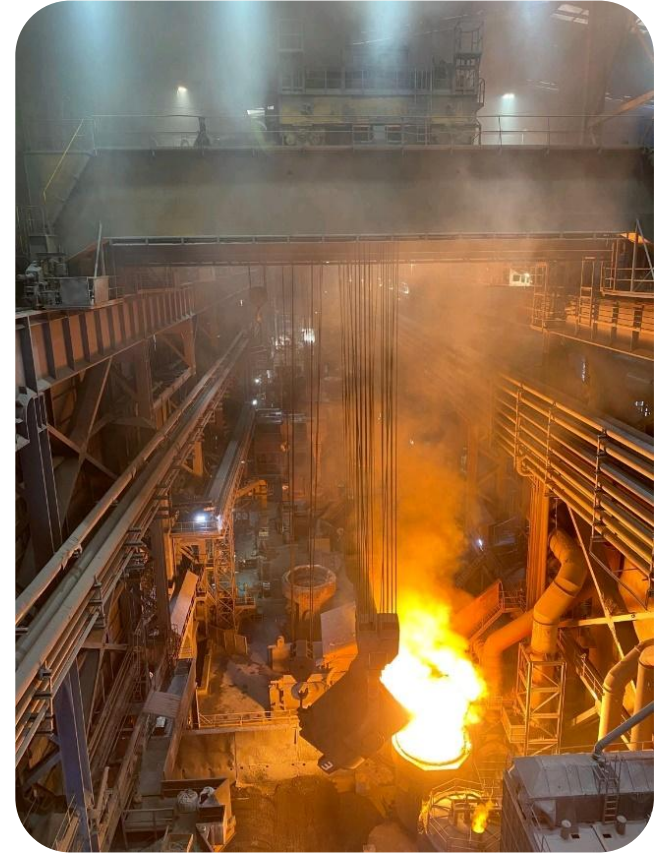
Communication Infrastructure of the Condition Monitoring System

The data from sensors installed on casting cranes and slab cranes' online condition monitoring systems are transmitted wirelessly.

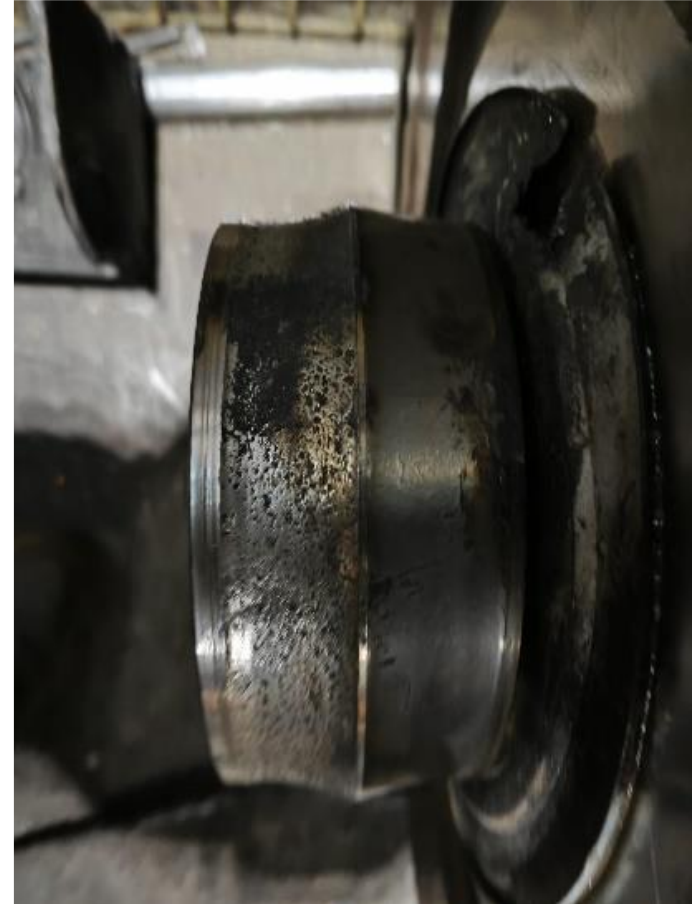
Indeed, after the replacement of the Wheel-West-North-Driven5-Outer wheel, when the removed wheel was disassembled, flaking damage was found on the inner ring of the bearing.

AVEVA Predictive Analytics System predicted the incoming failure **successfully**.
