White Paper: Cladding Attachments Put to the Test

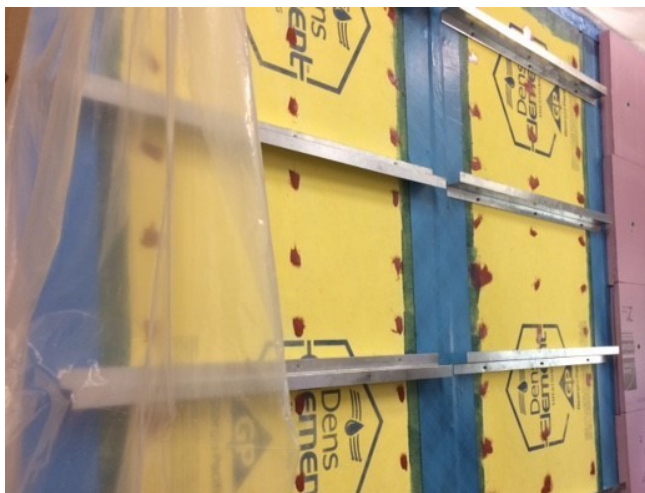
Picture 1: The DensElement[®] Barrier System with Z Girts installed with flanges up and down. The Z Girts are installed both tight and spaced from the WRB. Far right test wall shows XPS attached.

Cladding attachment clips and Z Girts were attached using two methods: a) tightly against the sheathing or WRB surface and b) spaced away from the sheathing or surface with different spacer thicknesses to allow water to flow behind the attachment.

The rigid insulation board was installed in a similar manner: with one section tight to the sheathing and two other sections spaced away from the sheathing at different spacing thicknesses to create a gap between the back of the insulation and the exterior face of the sheathing.

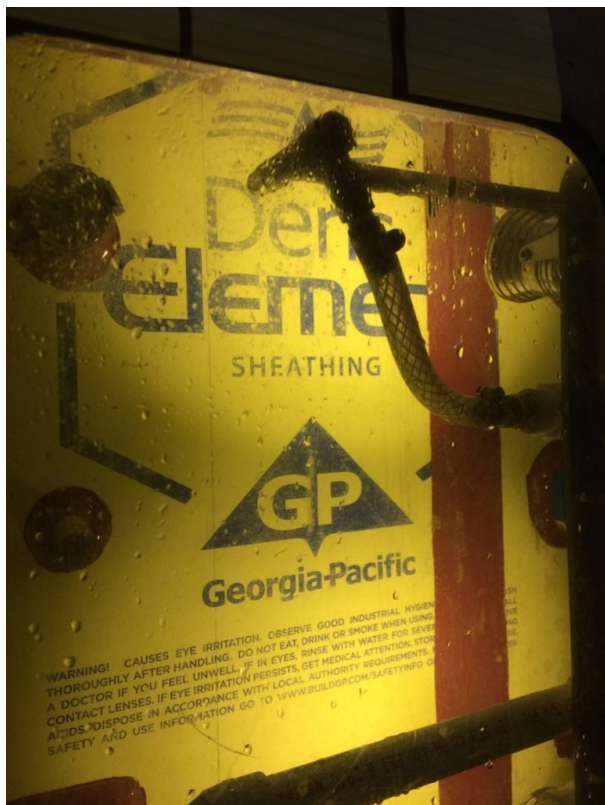
Picture: The DensElement[®] Barrier System tested per ASTM E331.

The test wall and water spray nozzles were set up per ASTM E331. The walls were then subjected to water spray duration and negative air pressure loads exceeding ASTM E331 protocol for code compliance.

Water application rate was 7.5 gallons per hour per sq. ft. instead of 5.0 gallons per hour per sq. ft.

Water was applied to the surface for 60 minutes at each pressure instead of 15 minutes at the single code required pressure of 140 Pa. Instead of the total test time length being 15 minutes, it was 5 hours! The wall(s) were tested for 60 minutes each at; 0 Pa, 300 Pa, 600 Pa, 900 Pa, and 1250 Pa. The last stage is equal to sustained winds of 100 mph!
