## INTRODUCTION

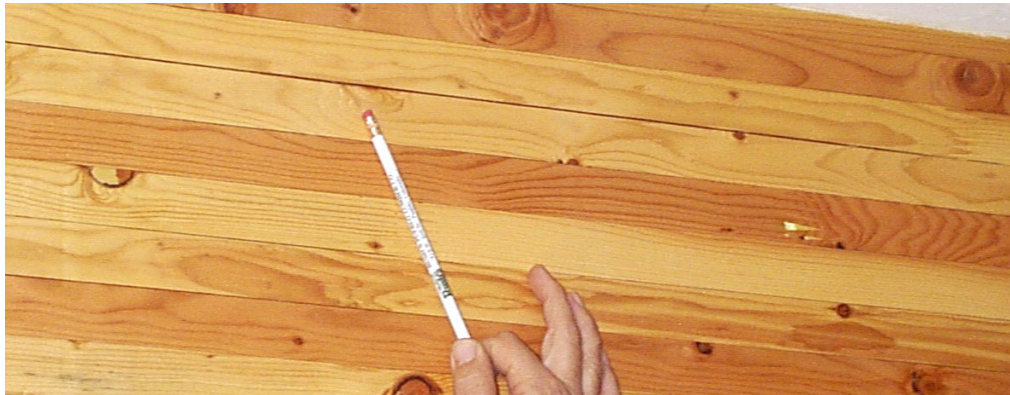
Checking along gluelines is usually most evident along a beam’s first lamination from the bottom edge. In exposed applications, the bottom lamination dries quicker than the rest of the beam since it is exposed to heat on three sides. Thus, stress builds up along the glueline and checking occurs. Though visually the “separation” of the tension lamination may be alarming, checking at this first lamination has minimal effects on the beam’s strength.
