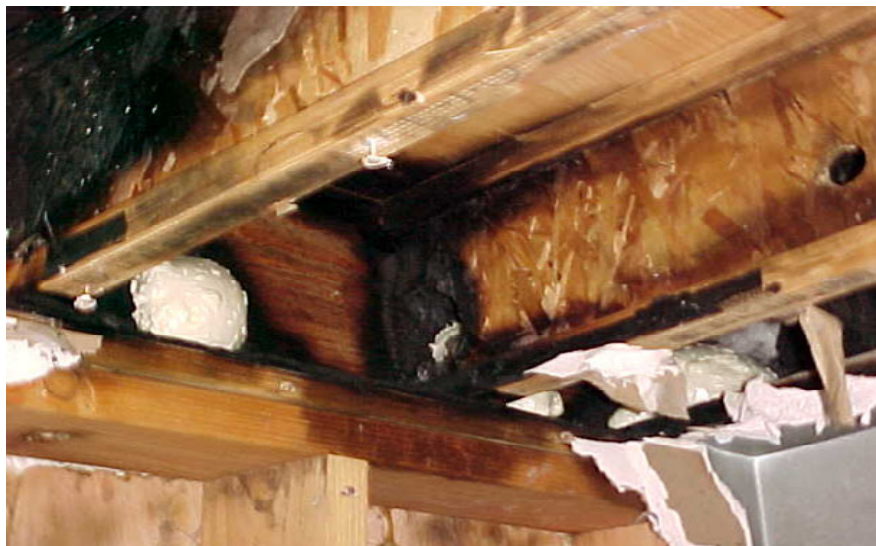
Example of Fire Damaged Engineered Wood Products

Therefore, if a Boise Cascade engineered wood product has surface char at any location, the product shall be replaced. Char is defined as any fire-related surface blemish that cannot be removed by wiping the surface. Since it is very difficult to determine the extent of strength reduction from fire damage, repairs for charred joists or beams are not allowed.
